-- *WILLETT POND DAM* --
PHASE I
INSPECTION / EVALUATION REPORT

Dam Name: Willett Pond Dam

NID ID#: MA00169

Date of Inspection: June 6, 2017

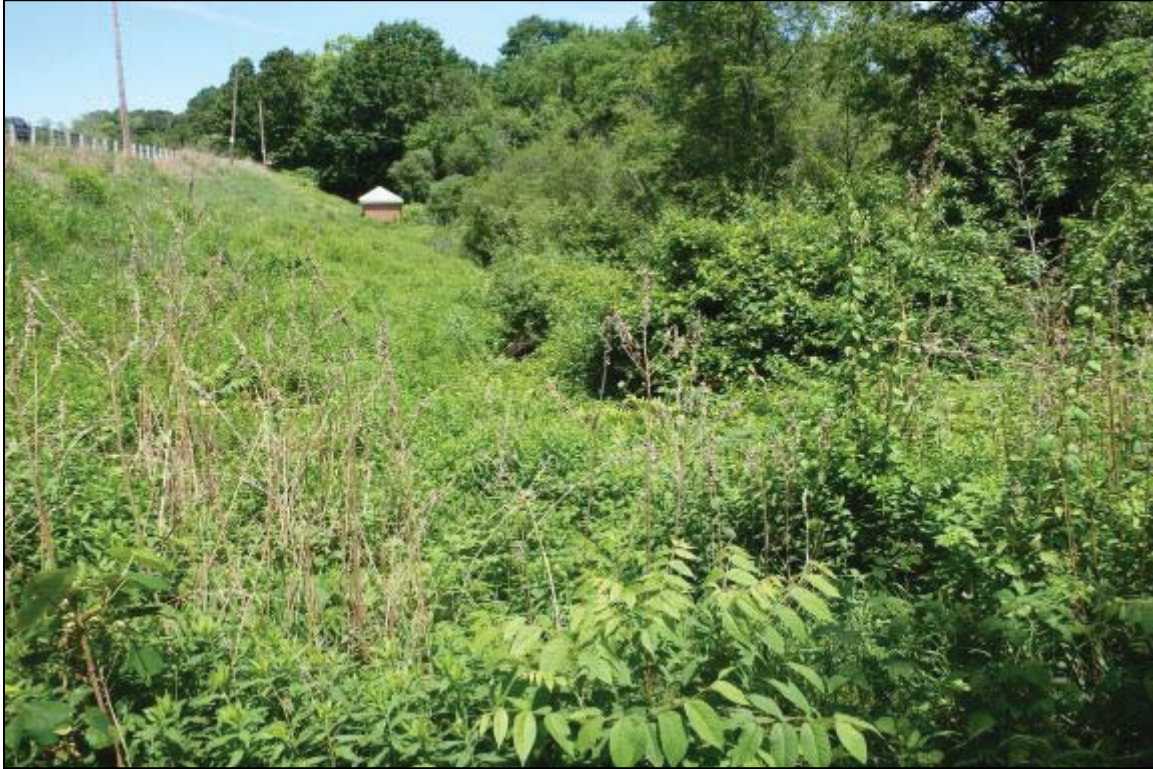
Photo 1: Overview of dam from downstream

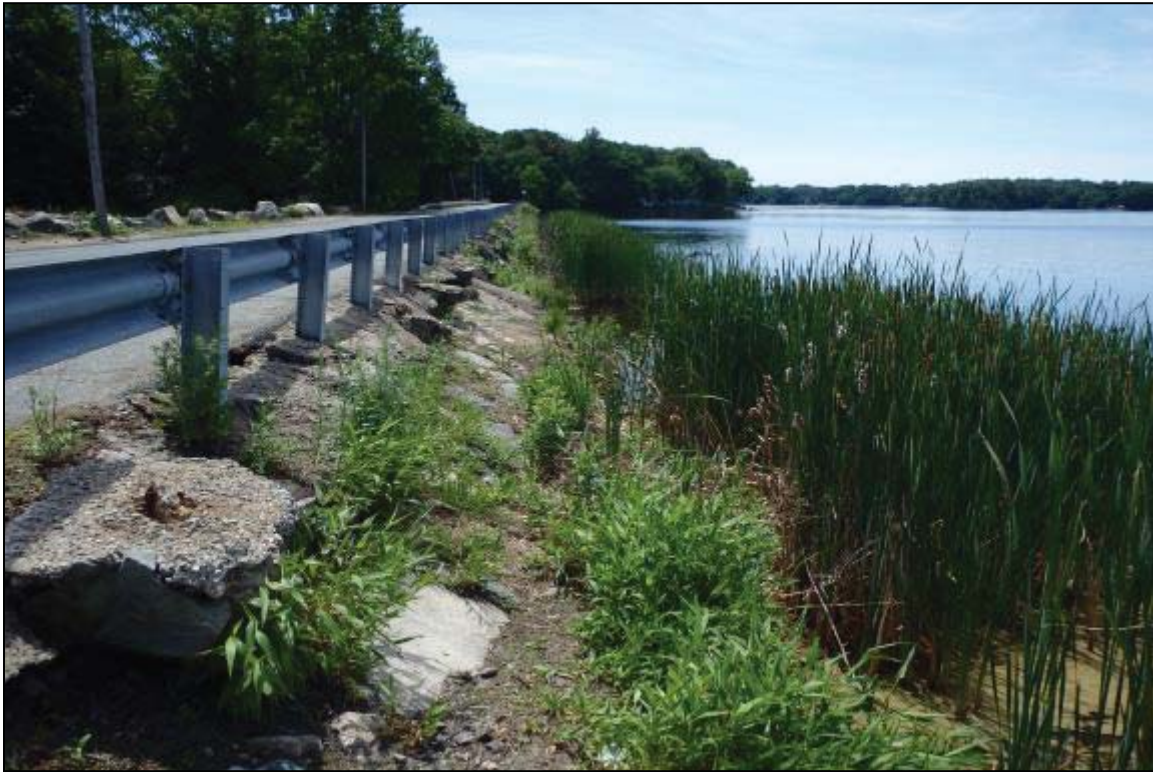
Photo 3: Overview of upstream face from left abutment

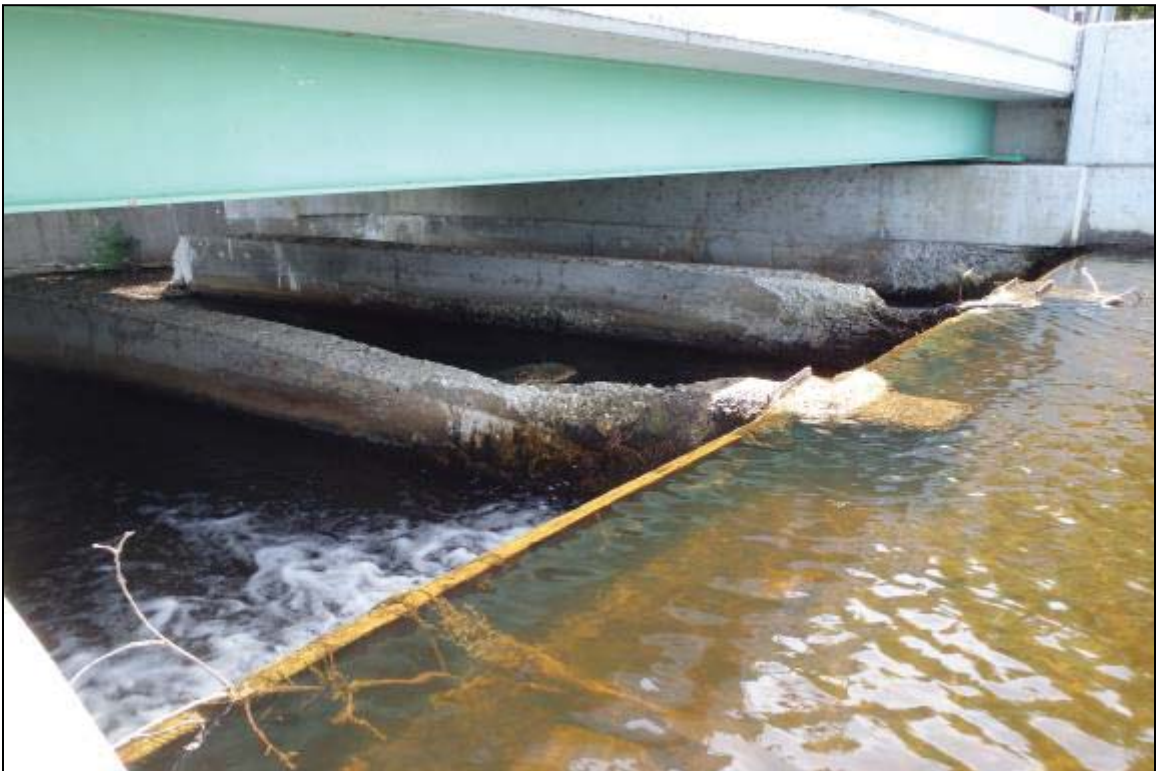
Photo 8: Overview of spillway from upstream

NAME OF DAM: Willett Pond Dam and Dike		STATE ID #: 6-11-220-02	
INSPECTION DATE: June 6, 2017		NID ID #: MA00169	
PRIMARY SPILLWAY			
AREA INSPECTED	CONDITION	OBSERVATIONS	NO ACTION MONITOR REPAIR
SPILLWAY	SPILLWAY TYPE	Concrete channel with vertical side walls	X
	WEIR TYPE	2 ft high stop logs	X
	SPILLWAY CONDITION	Fair	X
	TRAINING WALLS	Good	X
	SPILLWAY CONTROLS AND CONDITION	Wooden stop logs	X
	UNUSUAL MOVEMENT	None observed	X
	APPROACH AREA	Willet Pond - clear of debris	X
	DISCHARGE AREA	Stone lined channel, some concrete paving of channel	X
	DEBRIS	None observed	X
	WATER LEVEL AT TIME OF INSPECTION	Approximately 1" of flow over stop-logs el. 140.0 feet	X
ADDITIONAL COMMENTS: Spillway is undersized to pass the SDF

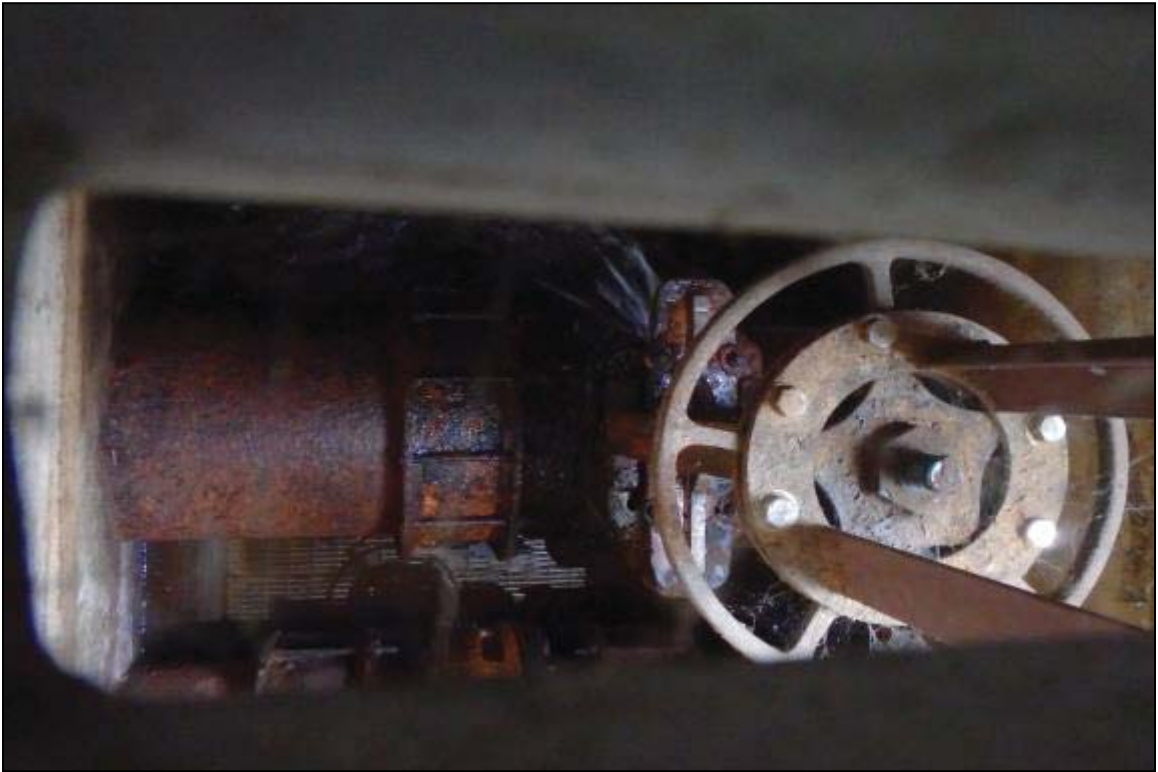
Photo 17: Overview of knife gate valve operator #1 (note leakage)

NAME OF DAM: Willett Pond Dam and Dike		STATE ID #: 6-11-220-02			
INSPECTION DATE: June 6, 2017		NID ID #: MA00169			
OUTLET WORKS					
AREA INSPECTED	CONDITION	OBSERVATIONS	NO ACTION	MONITOR	REPAIR
OUTLET WORKS	TYPE	Two 20-inch ductile iron pipes	X		
	INTAKE STRUCTURE	Submerged, not visible	X		
	TRASHRACK	Unknown	X		
	PRIMARY CLOSURE	Gate valves located within gate house near downstream toe, minor leakage		X	
	SECONDARY CLOSURE	N/A	X		
	CONDUIT	Two 20-inch ductile iron pipes	X		
	OUTLET STRUCTURE/HEADWALL	Discharge to concrete Parshall flume	X		
	EROSION ALONG TOE OF DAM	None observed	X		
	SEEPAGE/LEAKAGE	Minor leakage from gate valve housings		X	
	DEBRIS/BLOCKAGE	None observed	X		
UNUSUAL MOVEMENT	None observed	X			
DOWNSTREAM AREA	Heavily vegetated stream discharging to a small pond on Hawes brook	X			
MISCELLANEOUS					
ADDITIONAL COMMENTS: Sump pipe from gate house to the downstream wetland is broken inside the concrete chamber upstream of the Parshall Flume, allowing water in the flume to back up into the gate house. Temporary repair of pipe has been performed by NHLA

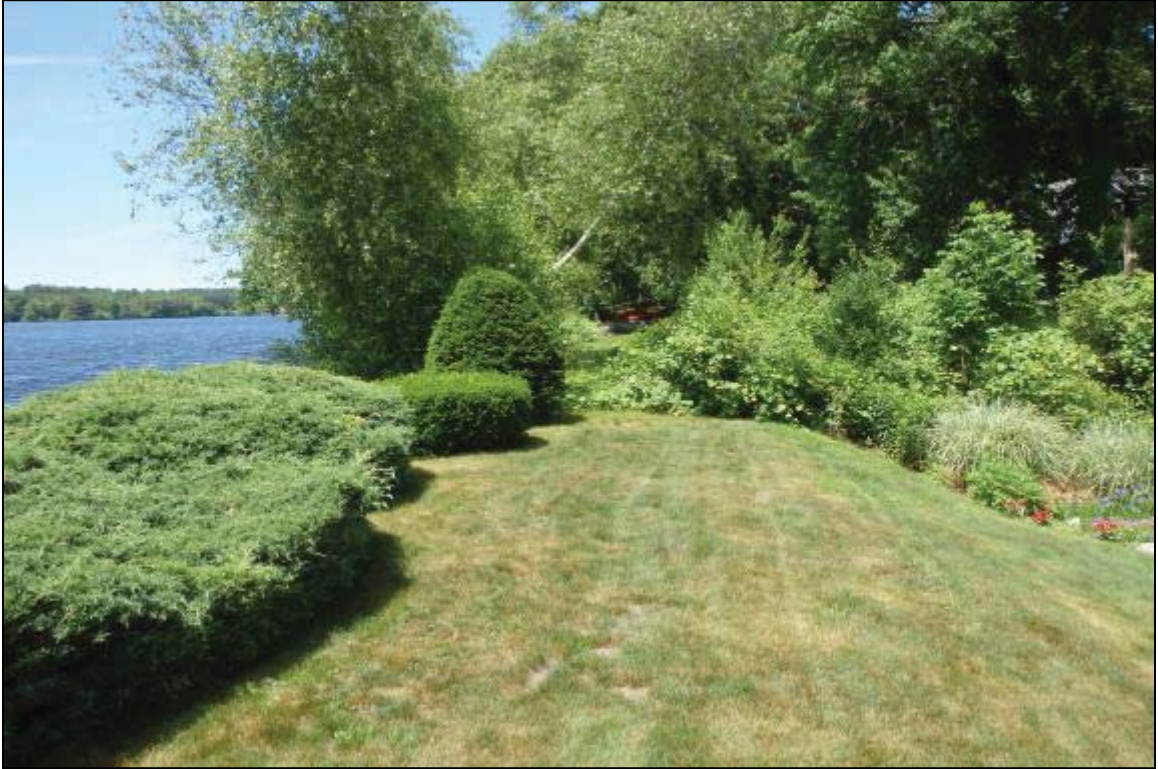
Photo 23: Dike crest facing left abutment

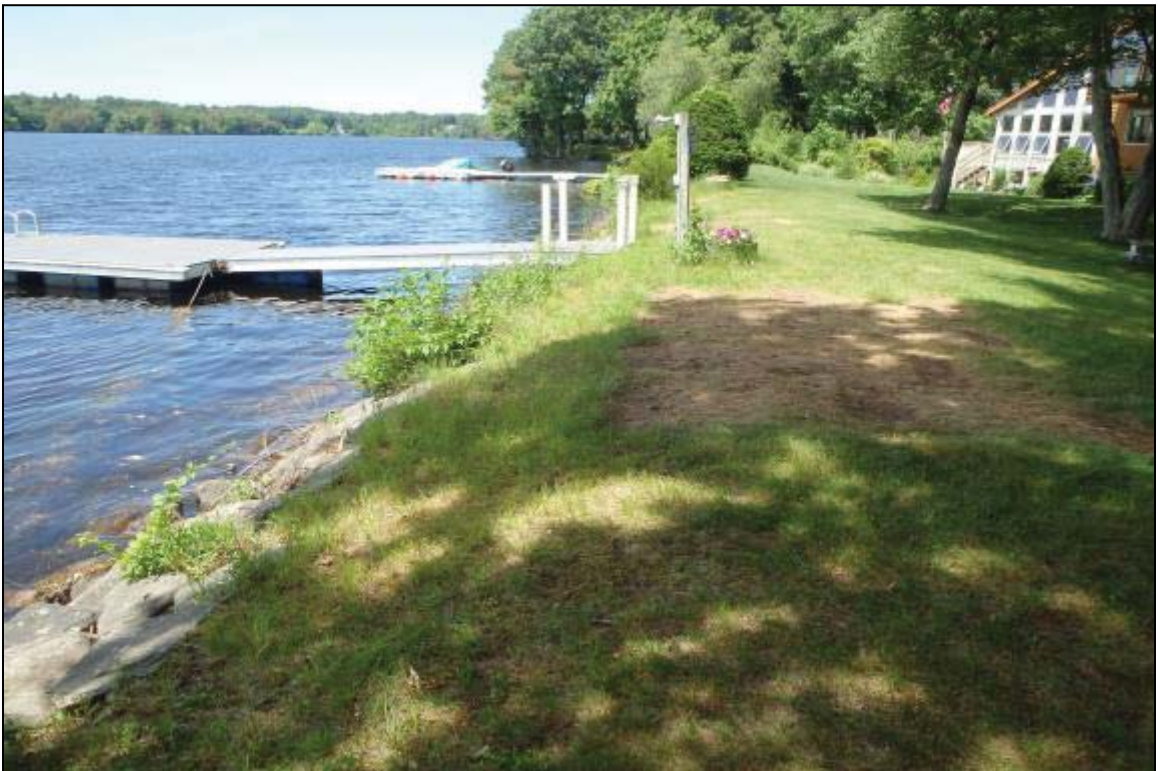
Photo 24: Dike upstream slope facing left abutment

NAME OF DAM: Willett Pond Dam and Dike		STATE ID #: 6-11-220-02	
INSPECTION DATE: June 6, 2017		NID ID #: MA00169	
DIKE EMBANKMENT (U/S SLOPE)			
AREA INSPECTED	CONDITION	OBSERVATIONS	NO ACTION MONITOR REPAIR
U/S SLOPE	1. SLIDE, SLOUGH, SCARP	None Observed	X
	2. SLOPE PROTECTION TYPE AND COND.	Placed rip-rap along majority of dike	X
	3. SINKHOLE/ANIMAL BURROWS	None Observed	X
	4. EMB.-ABUTMENT CONTACT	Good	X
	5. EROSION	Some areas worn, possibly due to pedestrian traffic	X
	6. UNUSUAL MOVEMENT	None Observed	X
	7. VEGETATION (PRESENCE/CONDITION)	Small trees and bushes along upstream face near water level	X
ADDITIONAL COMMENTS:
